DEPARTMENT OF TRANSPORTATION**DIVISION OF ENGINEERING SERVICES**

Contract #: 04-0120F4Cty: SF/ALA Rte: 80 PM: 13.2/13.9File #: 69.28**WELDING INSPECTION REPORT****Resident Engineer:** Siegenthaler, Peter**Address:** 333 Burma Road**City:** Oakland, CA 94607**Report No:** WIR-017832**Date Inspected:** 06-Nov-2010**Project Name:** SAS Superstructure**OSM Arrival Time:** 700**Prime Contractor:** American Bridge/Fluor Enterprises, a JV**OSM Departure Time:** 1900**Contractor:** Zhenhua Port Machinery Company, Ltd (ZPMC), Changxing Island **Location:** Shanghai, China**CWI Name:** Zhu Zhong Hai.**CWI Present:** Yes No**Inspected CWI report:** Yes No N/A**Rod Oven in Use:** Yes No N/A**Electrode to specification:** Yes No N/A**Weld Procedures Followed:** Yes No N/A**Qualified Welders:** Yes No N/A**Verified Joint Fit-up:** Yes No N/A**Approved Drawings:** Yes No N/A**Approved WPS:** Yes No N/A**Delayed / Cancelled:** Yes No N/A**Bridge No:** 34-0006**Component:** OBG components.**Summary of Items Observed:**

OBG Seg 11BE and Seg 11CE:

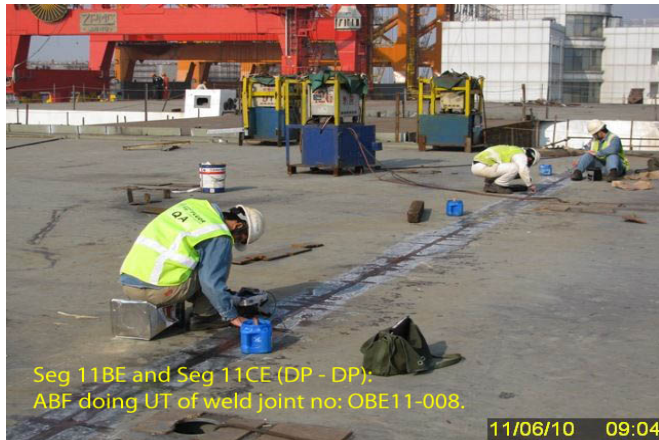
This QA Inspector observed ABF personnel doing Ultrasonic Testing (UT) of weld joint no: OBE11-008 [Deck Panel (DP) to DP – transverse splice weld]. See attached photo for further details.
